EDGEWATER VILLAGE

(NDI-ID NO. MD-83)

PHASE I INSPECTION REPORT

NATIONAL DAM INSPECTION PROGRAM

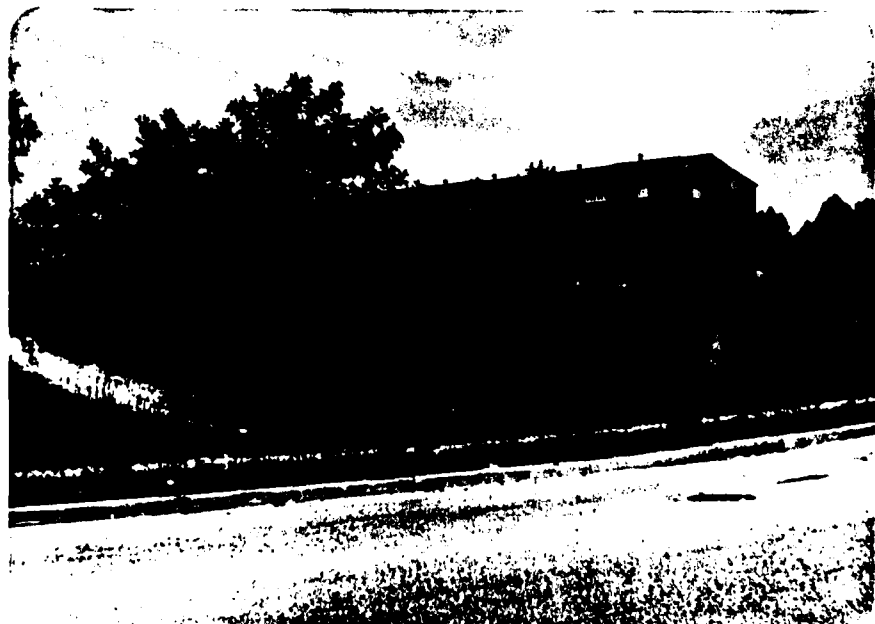
Trees with diameters as great as 6 inches were noted along the crest and downstream slope of the embankment.

B. Left end of downstream slope of dam
